**INSPECTION REPORT  
Lanxess Storm Sewer Leak/Discharge  
To AOC 2 Former Ponds Remediation Area**

**HATCO CORPORATION SITE  
FORDS, NEW JERSEY**

**July 2018**

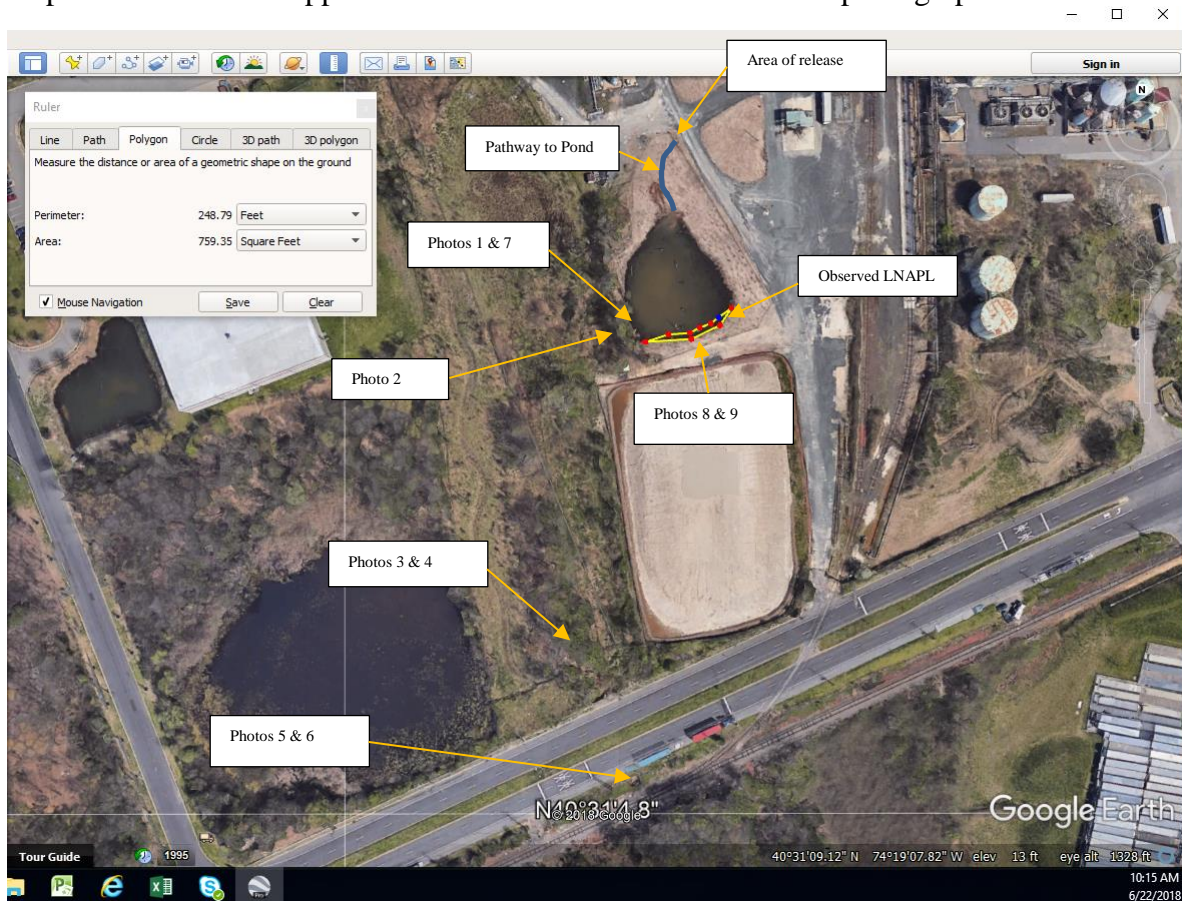
This report provides a summary of initial observations and response actions taken on June 19. The map below shows the approximate locations of observations and photographs
